PUBLIC ROADS

VOL. 13, NO. 11 ▽ JANUARY, 1933

Surface Treatment of Topsoil Roads 169

Effect of Size of Specimen, Size of Aggregate, and Method of Loading Upon the Uniformity of Flexural Strength Tests 177

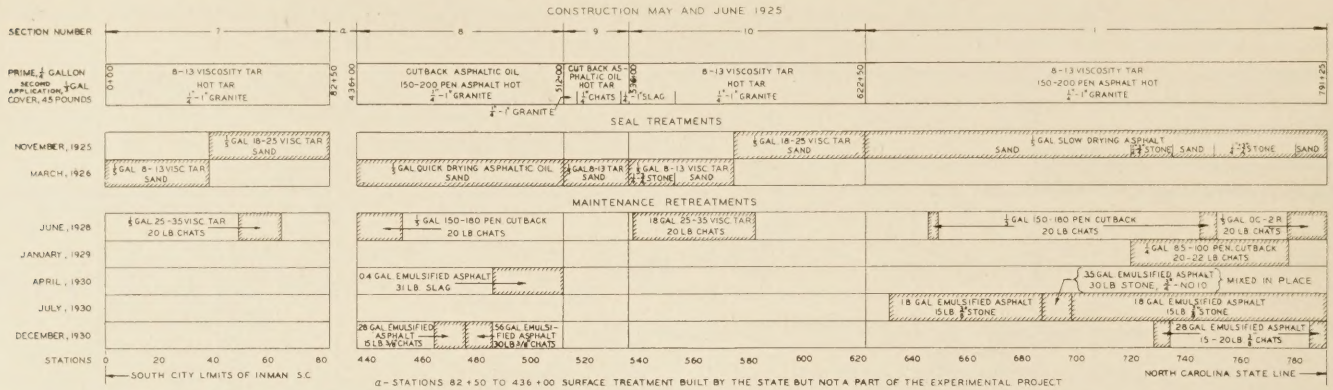
FIGURE 1.—CHART SHOWING NATURE AND EXTENT OF TREATMENTS APPLIED TO EXPERIMENTAL SECTIONS

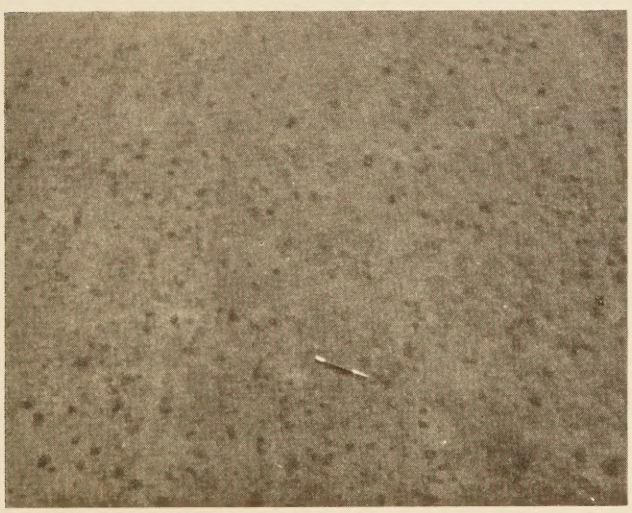
FIGURE 5.—DETAILED VIEW OF SECTION 9, WHICH WAS NEVER RE-TREATED AFTER CONSTRUCTION, PHOTOGRAPHED IN APRIL, 1930

Section 9 also was permitted to go through the first winter without a seal as its surface was smooth and showed no defects. The portion on which chats were used resembled a Topeka pavement, while the slag-covered portion had a rough and granular texture. The former required some little patching during the winter but its condition in general was much better than the latter.

The entire section was given a seal coat in March, 1926, consisting of one-fifth gallon of 8 to 13 viscosity tar and a cover of sand. After that date the section received no further treatments. This fact, as well as the low maintenance cost, indicates its continued excellent behavior. It continued in the best condition of any of the sections, the chat-covered portion appearing somewhat better than the slag, which was more open. Figures 5 and 6 are typical illustrations of this section.

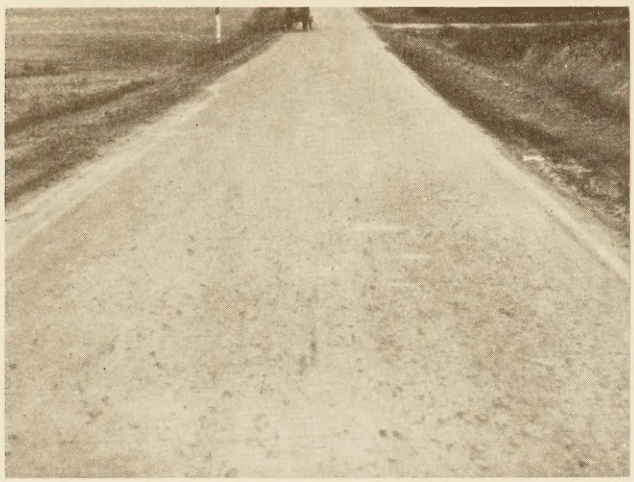
FIGURE 7.—TYPICAL CONDITION OF THE PORTION OF SECTION 10 WHICH WAS NEVER RE-TREATED

than it should have been. Had the project been continued it is believed that a light re-treatment would have been desirable on this area. The portion never re-treated showed no need of immediate re-treatment. Figure 7 is a typical view showing its excellent condition.
